Ilonka Aylward's Complaint

Exhibit 13

Subject: Evaluation of Potential Impact to 2813 Hinsdale St. by a Proposed Charlotte Mecklenburg Storm Water Drainage Improvements Project

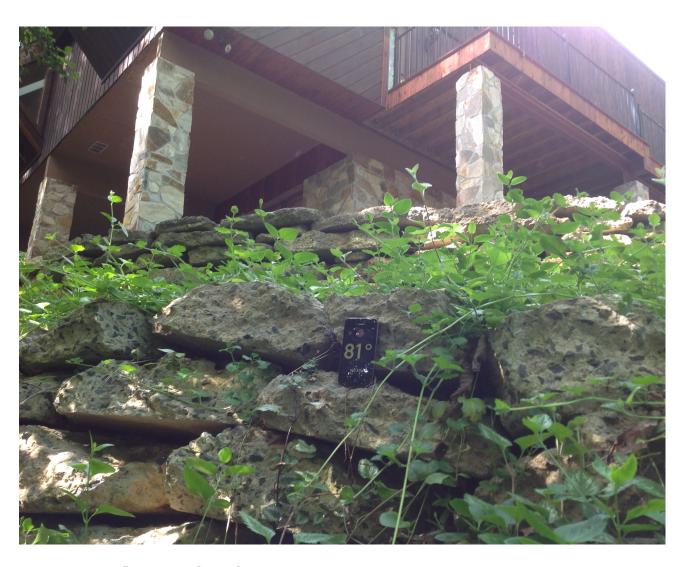
Attach. 4 View of the slope where Stormwater wants to grade

My house sits on the right bank of a small creek, on a very steep slope.

(EPA defines "steep slope" as 15 degrees; mine is 16 in parts, and 80 in parts, so I kid you not when I say "steep.")

Bank erosion immediately under the house was graded "severe."

Charlotte Stromwater wants to: grade this steep, eroded slope; blast bedrock under it, vibrate it; store machinery and materials on it. I resist and offer alternative solution, which is cheaper, safer, and designed by Professional Engineer with municipal and hydrological expertise.

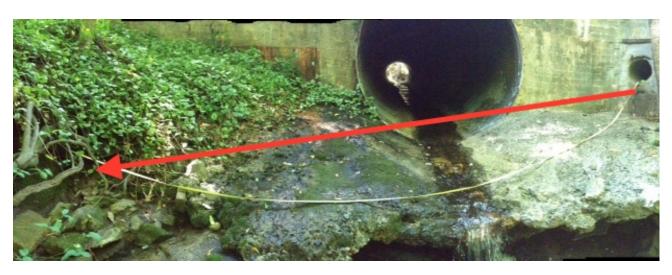
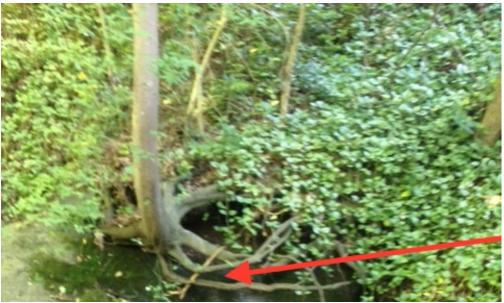
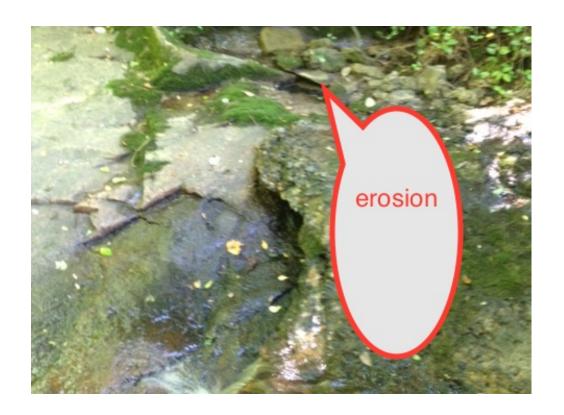
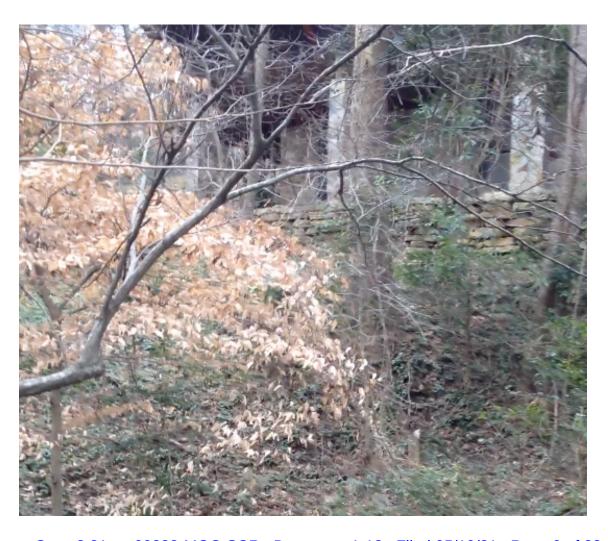
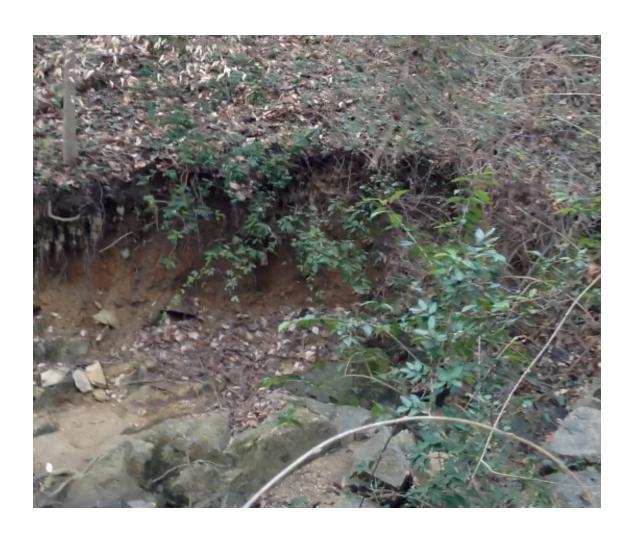
Attach. 6B, 6C Photos of some eroded areas

US Corps agrees with me that one of the erosion culprits is the position of Stormwater drain. Stormwater shoots from left bank into right (my house) bank. It cut a hole in right bank.

One other quick question and sorry to keep bugging you on this. Dr. Aylward sent me some more pictures and she has pointed out a little stormwater pipe that is directed towards the bank where she says some erosion has occurred (minor bank undercutting based on the picture). Looks like the stormwater pipe will be placed in relatively the same location post construction and at a 90 degree angle to the stream flow. We often ask that stormwater not come in a 90 degree angle to reduce potential erosion on the opposite bank. Again, I know that you are much earlier in the planning/designing stage that I would normally see a plan so this may get addressed as the process moves forward, but in order to address the concerns she has that are actually pertinent to regulatory, thought I'd go ahead and mention this and see if you have considered placing this pipe so it is not perpendicular to the stream or otherwise considered the potential impact of directing stormflow across the stream.

Crystal C. Amschler Project Manager Asheville Regulatory Field Office 151 Patton Avenue, Room 208 Asheville, NC 28403 (828)-271-7980 Ext 4231 I mention this problem, because design change proposed by Diamond Engineering Opinion Letter 2019 (rotating wing wall end) helps this problem as well.
